# Journal of Materials and Engineering Structures

## Dolphin Structures Health Monitoring: A Case Study in Hai Phong, Vietnam

Nguyen Anh Dan<sup>a</sup>, Nguyen Viet Thanh<sup>a,\*</sup>

<sup>a</sup> Faculty of Civil Engineering, University of Transport and Communications, Hanoi, Vietnam

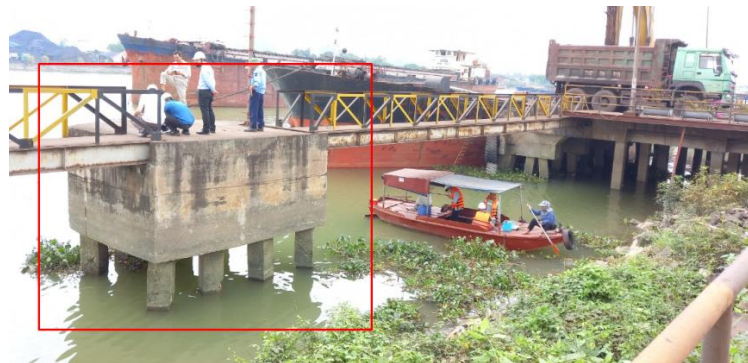
Currently, the dolphin remains in service for daily berthing and mooring operations. However, after years of operation, signs of deterioration have been observed, particularly severe cracking and spalling of piles. Fig. 2 illustrates the overall condition of the structure.

**Fig. 2– Overall view of the dolphin structure**

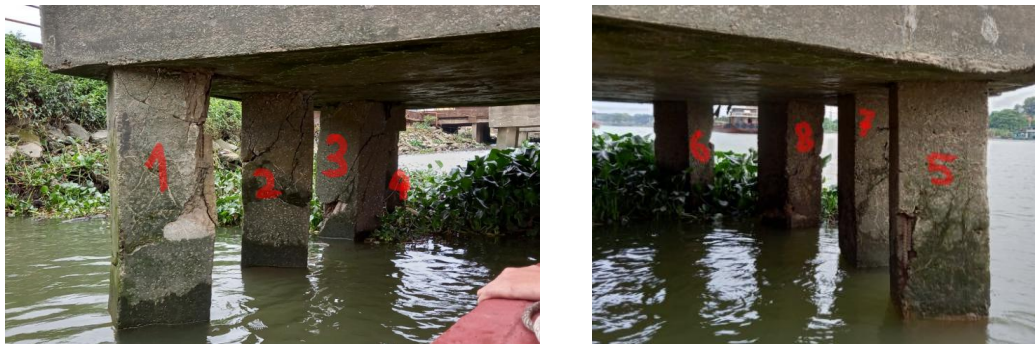
The inspection results conducted by the assessment unit revealed that the dolphin structure had suffered severe damage, especially in the pile system, as shown in Fig. 3. All piles exhibited cracking and spalling within approximately 1 m below the cap bottom. The entire concrete portion of the pile heads within this zone had fractured. Numerous horizontal and diagonal cracks ranging from 2–10 mm widths were observed. Large concrete fragments detached, with the most significant piece measuring  $40 \times 20$  cm at a pile corner. The concrete surface was honeycombed, and hammer testing indicated debonding and loss of integrity. The piles showed bending and a tendency to fracture about 60 cm below the cap bottom.

*Fig. 3–Current state of dolphin piles*

1. Severe Material Degradation: All foundation piles exhibited critical structural failures, characterized by severe cracking and crushing at the pile heads within a 1.2-meter zone below the cap. Significant distress was observed, with crack widths reaching 1.0 cm and extensive concrete spalling (up to 50 × 30 cm) that exposed primary reinforcement bars. Notably, a consistent fracture pattern was identified in the majority of piles at a depth of approximately 0.6 m below the cap interface.

4. The investigation confirms that the structure is in a state of terminal deterioration and no longer meets the safety requirements for continued operation. Immediate intervention is mandatory; the structure must undergo extensive strengthening, comprehensive repair, or complete replacement to mitigate the risk of catastrophic failure.

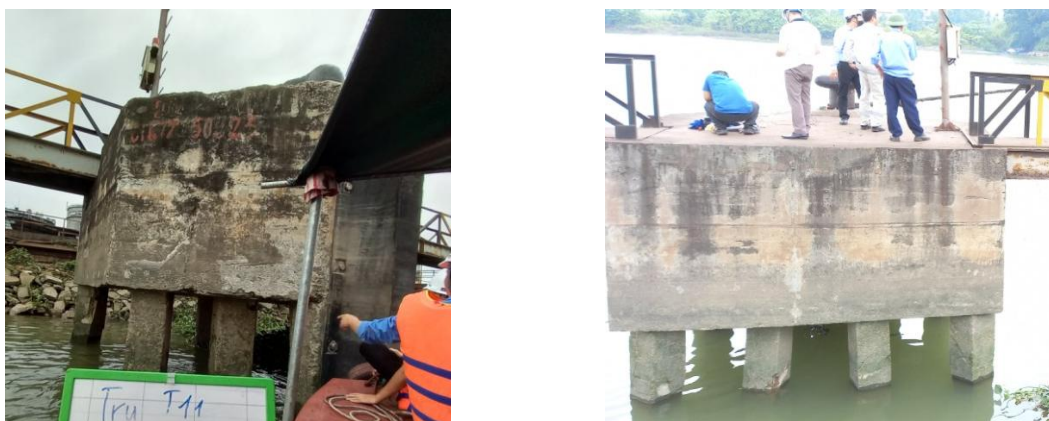
The current status of the cap is shown in Fig. 4. The cap maintained its designed geometry and dimensions; however, a visual inspection indicated that the RC concrete was subjected to chemical attack and surface degradation. Multiple areas of spalling were observed, especially on the river-facing side. Several edges were broken off.

*Fig. 4–Current state of dolphin cap*

2. Component Deterioration: Both the piles and the structural cap demonstrated advanced stages of deterioration. The river-facing surface of the cap, in particular, showed widespread spalling, indicating significant environmental and operational impact on the concrete integrity.

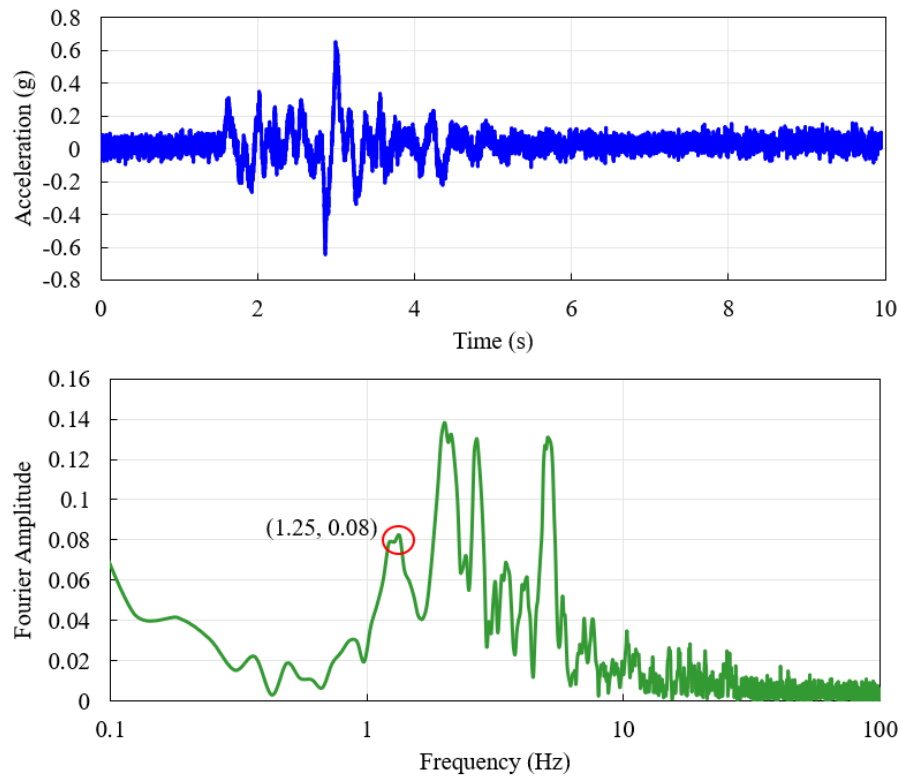
**Fig. 7– Acceleration response parallel to the riverbank (Test 1)**

| Vibration Direction | Natural Frequency (Hz) | Average Result (Hz) |
|---|---|---|
| Parallel to the riverbank | Test 1: 1.25 | 1.23 |

| Vibration Direction | Measured Natural Frequency (Hz) | Design Natural Frequency (numerical model), Hz | Health index | Level |
|---|---|---|---|---|
| Parallel to the riverbank | 1.23 | 2.57 | $\kappa = 0.48$ | A1 |

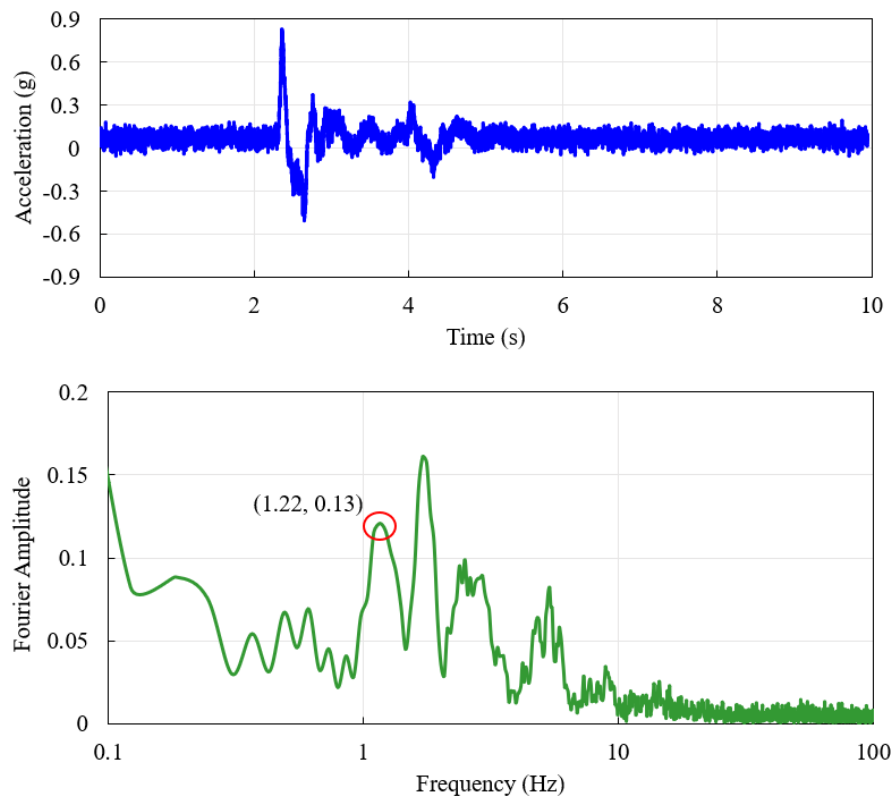
**Fig. 8– Acceleration response parallel to the riverbank (Test 2)**

| Vibration Direction | Natural Frequency (Hz) | Average Result (Hz) |
|---|---|---|
| | Test 2: 1.22 | |

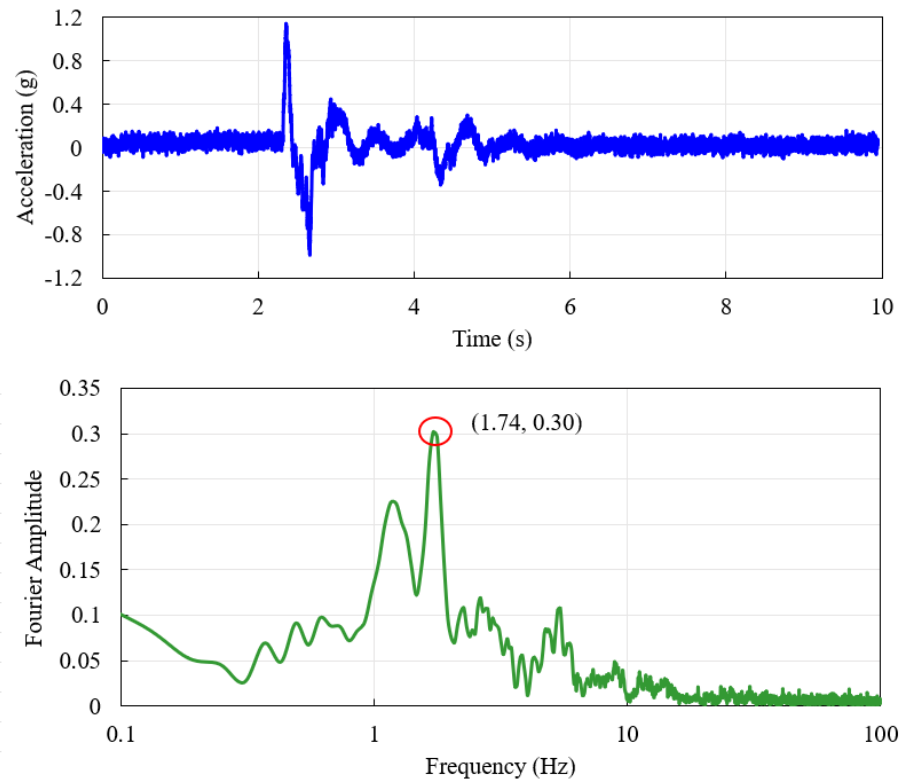
**Fig. 9 – Acceleration response perpendicular to the riverbank (Test 1)**

| Vibration Direction | Natural Frequency (Hz) | Average Result (Hz) |
|---|---|---|
| Perpendicular to the riverbank | Test 1: 1.74 | 1.86 |

| Vibration Direction | Measured Natural Frequency (Hz) | Design Natural Frequency (numerical model), Hz | Health index | Level |
|---|---|---|---|---|
| Perpendicular to the riverbank | 1.86 | 3.04 | $\kappa = 0.61$ | A1 |

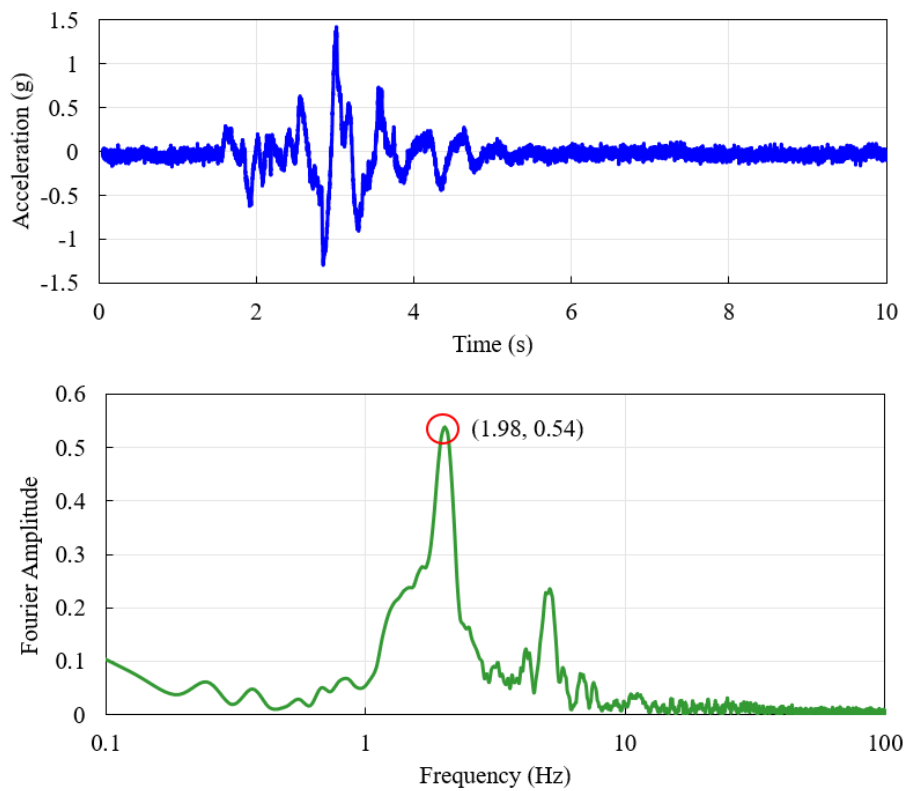
**Fig. 10– Acceleration response perpendicular to the riverbank (Test 2)**

| Vibration Direction | Natural Frequency (Hz) | Average Result (Hz) |
|---|---|---|
| | Test 2: 1.98 | |
