# Journal of Materials and Engineering Structures

### Experimental study on transverse behavior of concrete box girder bridges with strutted wing slabs

In 2023, the first box girder bridge with strutted wing slabs in Vietnam was put into use in the Ring Road II Viaduct Project in Hanoi. As this is an innovative type of traditional box girder bridges and completely new in Vietnam, prior to the commencement of the project, an experimental program was conducted to check the construction technology and obtain valuable experimental data for design and further numerical analyses. A full-scale girder segment with a width of 18.7 m, a length of 6 m and height of 2.5 m, incorporating steel pipe struts, was fabricated. Three distinct load cases were conducted to investigate the transverse behavior of strutted wing slabs, steel pipe struts and connections under the most unfavorable load conditions at Service Limit State. This paper presents a detailed experimental program with test results. It is shown that with applied loads varying from 1.2 to 1.5 times the service load, both the deck slab and steel pipe struts still exhibited linear manner, maintaining sufficient load-bearing capacity. H

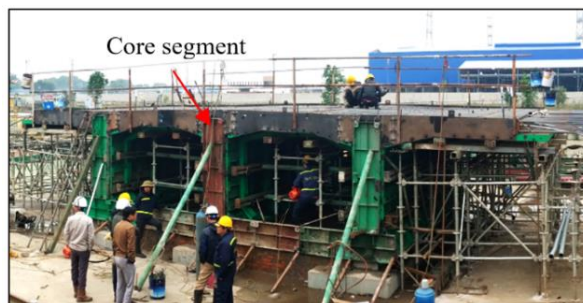
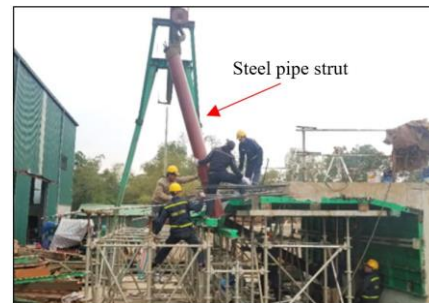
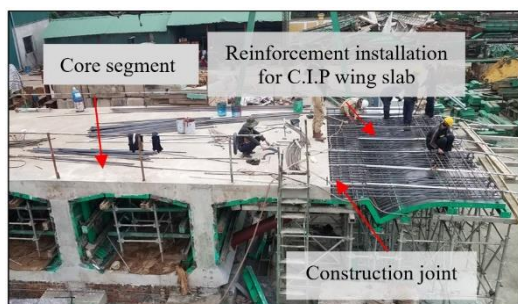
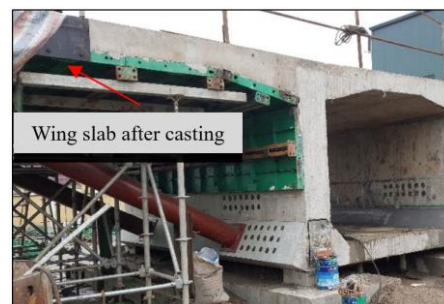
**Fig. 5 – Specimen fabrication procedure: (a) → (b) → (c) → (d)**

a) Core segment was cast

b) Steel pipe struts were erected

a) Reinforcement installation for the wing slab

b) After the whole wing slab was cast

The specimen was cast in two separate stages. Initially, the core segment, with a width of 12 m as depicted in Fig. 1, was cast. Two days later, the formwork of the core segment was removed, and the steel pipe struts were erected. Subsequently, the casting of the wing slab took place, 25 days after the core segment was cast. Once the wing slab achieved sufficient strength (3 days after casting), transverse tendons were prestressed, and the concrete deck began to undergo post-tensioning, transforming into a prestressed slab. It's important to note that this construction procedure followed a fabrication plan for a box girder bridge with strutted wing slabs in Japan [25]. In this project, the concrete core segment was precast, and the cast-in-place wing slab was then produced at the construction site. Fig. 5 illustrates the procedure for fabricating the girder segment.

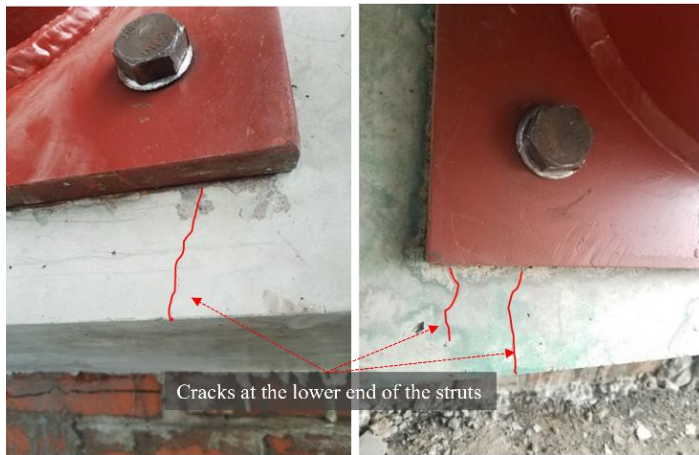
**Fig. 6 - Cracks at the lower end of the struts during fabrication**

The specimen underwent close monitoring throughout the fabrication process to detect any defects or cracks that would have arisen. Inspection procedures involved both visual examination and the utilization of specialized crack monitoring equipment. Generally, no major cracks were found in the girder segment during fabrication, except for some shrinkage cracks. However, a few cracks, with a maximum width of about 0.6 mm and a length of 15 cm, were observed in the concrete at the lower end of the steel struts, as depicted in Fig. 6. These cracks likely developed due to the forces exerted during the tightening of bolts. Additionally, it was noted that the two steel plates in connections, one embedded in the concrete and the other at the lower end of the steel struts, were not fully aligned. Further investigation into the concrete strength in these areas was conducted using Rebound Hammer Tests, as illustrated in Fig. 7. The results showed that the concrete at several locations did not meet the required strength.

The cracks observed at the connection between the core segment and the lower end of the struts during construction suggested that, in practical applications, it's advisable not to position the steel plates too close to the bottom of the girder. This adjustment can help minimize the likelihood of such cracks occurring. Additionally, extending the length of the studs could effectively reduce the bond stress between the studs and the concrete. Moreover, it's essential to meticulously design the detailing of the connection between the concrete and the steel pipe struts. This includes avoiding the arrangement of dense reinforcement, as it can hinder the proper filling of concrete, resulting in poor concrete strength in these areas. In addition, it is necessary to employ appropriate casting methods to ensure the solidity and strength of concrete at both ends of the struts. Most importantly, precise technical instructions for tightening high-strength bolts are necessary. It is crucial to clearly state that no bolt should be tightened first to fix the strut, but rather, they should be tightened evenly and sequentially according to the procedure.

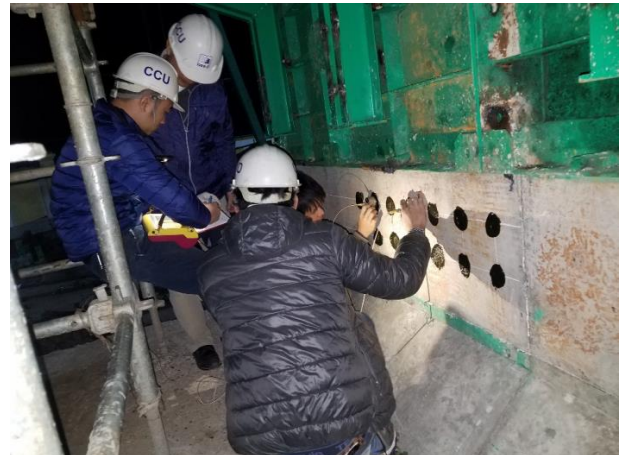
**Fig. 7 - Measuring concrete strength using Rebound Hammer Test**

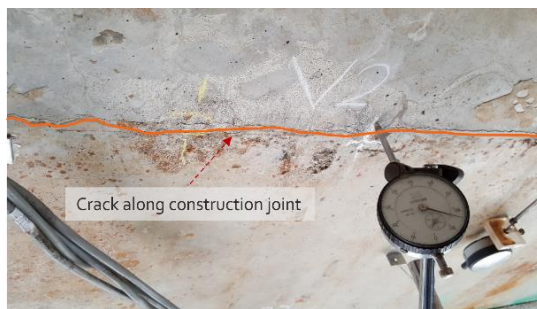
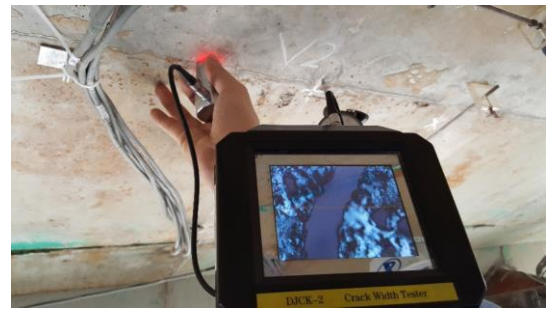
**a) Cracks occurred at the construction joint at an applied load of 52 kN**

**b) Monitoring crack opening during the test**

**Fig. 22 – A crack occurred at the construction joint (right side of the wing slab)**

The deflection of the girder segment at a number of critical points, as measured by installed dial indicators, is depicted in Fig. 21. It is evident from the load-displacement relationships that there is a linear behavior. At a load of 52 kN (40% of the maximum test load), noticeable changes occurred in the slopes of all the curves. This alteration occurred due to the formation of cracks at the construction joint as shown in Fig. 22. Following these changes in the deflection slopes, the

- In Load Case 2, cracks were observed in the construction joint between the core segment and the cast-in-place wing slabs. Therefore, implementing a technique to manage the interface between concrete cast in different stages is necessary to prevent early cracks.

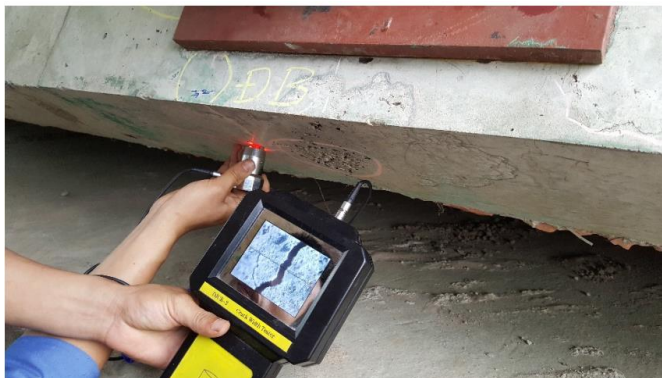
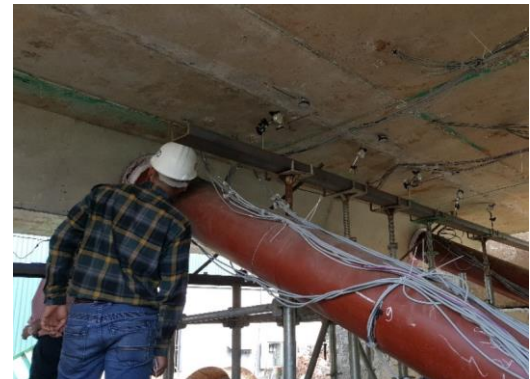
a) Cracks at the lower end of Strut 3

b) Monitoring cracks at the upper end of Strut 3

Fig. 27 – Cracks occurred in concrete under Load Case 3
