# Journal of Materials and Engineering Structures

## Research Paper

### Real-Time and Full-Scale Numerical Analysis and Monitoring of Displacements in the Left Bank of the Tabellout RCC Arch Dam during Construction and Operation, Jijel Province, Algeria

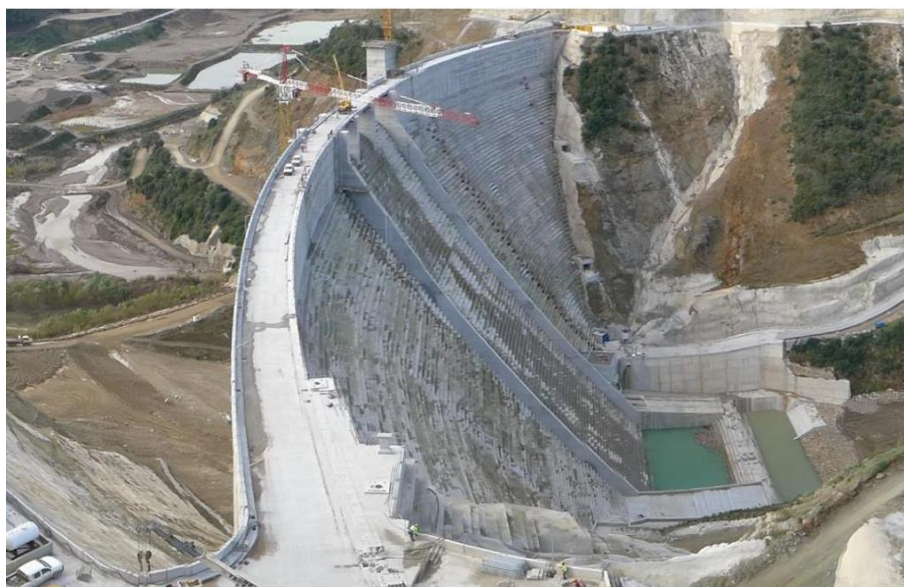
**Fig. 4 – a) 3D Design of the Tabellout Arch-Gravity Dam [22]; b) Photo of the Tabellout Arch-Gravity Dam in RCC before its Exploitation.**

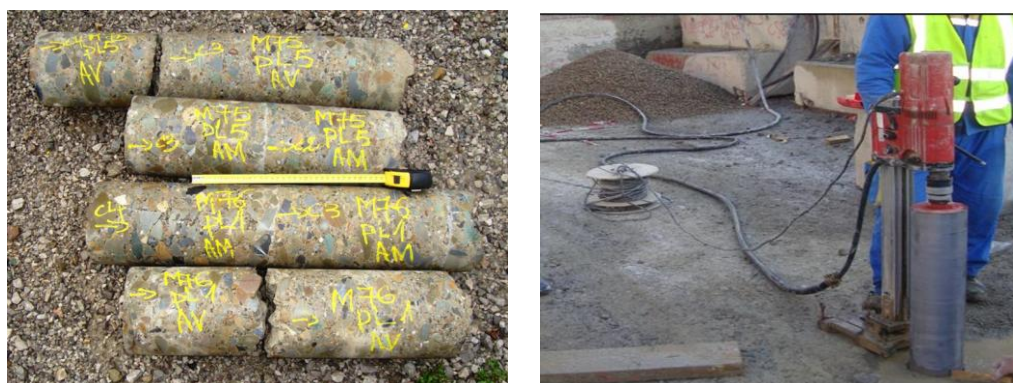
**Fig. 9 – a) RCC cores taken by the laboratory on Plot 1 of Massif 76 and Plot 5 of Massif 75 with a diameter of 150 mm. b) Hilti coring machine capable of reaching a depth of 60 cm on the RCC layer.**

Since November 2013, the company's laboratory (RAZEL) has been conducting core drilling on RCC layers after compaction (4-5 days) using a 150 mm diameter, 600 mm depth core drill (Figure 9). A "Hilti model" coring machine is used on the top layer of the block and progressively at the end of each layer. Three cores are taken—one downstream and two upstream—to obtain representative samples from the last and second-to-last layers (C4 and C3) of the block and massif. The average recovery length of the cores is approximately 50-60 cm.

These cores allow for the assessment of the bonding condition between layers 4 and 3 of the RCC at upstream, central, and downstream positions, the density of the RCC after compaction, the texture and homogeneity of the RCC, which are influenced by the presence or absence of the retarder, and the Modulus of Deformation (Table 5). The following table summarizes the positions of the core samples, the strength values of the cores compared to the test specimens, and the modulus of deformation values of the cores:

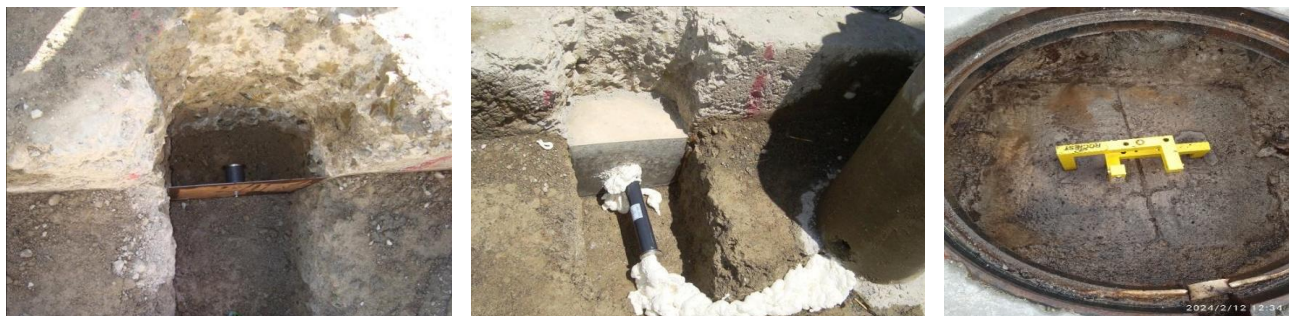
**Fig. 10– Installation of the Crack Meter between Plot 4 and 5 (Before and After Sealing).**

The installation of "vibrating wire crack meters" began on June 17, 2013, between plots 4 and 5 at section PM 182 at elevation +225 (Figure 10). As of February 28, 2015, the installation of crack meter KA 24, between plots 6 and 7 at section PM 82.4 (figure A1), remains pending. The reference reading will be established once the readings become stable over several consecutive days.
