# Journal of Materials and Engineering Structures

## Research Paper

### Structural Health Monitoring of Steel Girder Bridge Using Photogrammetry and LiDAR Scan Technology: Proof of Concept

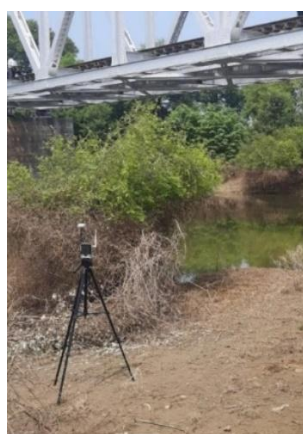
**Fig. 2 – (a) DJI M210 RTK with Z30 camera (b) RTK base station and (c) DJI Zemmuse 30 camera.**

The drones M210 quadcopter with RTK was chosen as the primary UAV. The platform DJI M210 is versatile and compatible with multiple DJI's was considered, Fig. 2(a-b). In addition to standard downward camera mounting gimbal, upward camera mounted gimbal was used to take under the bridge photographs.

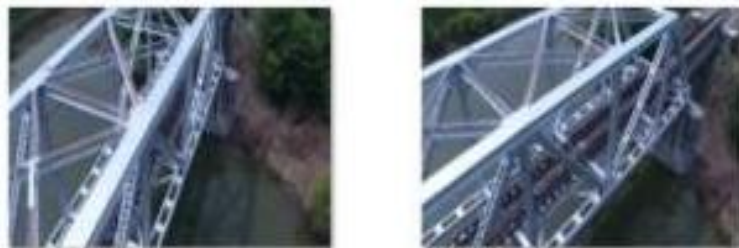
**Fig. 4 - (a) proposed and (b) actual flight path along with (c) sensor position spatial locations and (d) typical georeferenced photographs.**

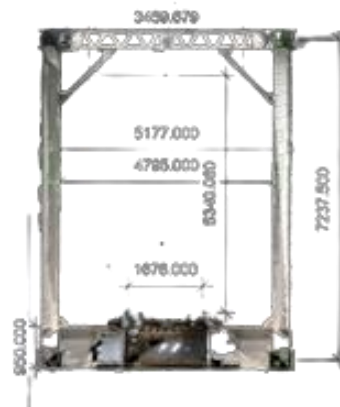
**Fig. 6 - Typical bridge (a) elevation and (b) cross sectional view with related dimensions.**

The typical schedule of the dimension diagram of elevation view is shown in Fig. 6(a). Overall, it was observed that the schedule of dimensions predicted the digital model closely matching with the RDSO drawings. It was observed that the change in overall length from the digital data was found to be 2 mm, whereas the same was found to be 10 mm measured manually at the site. In case of distance between the centre of bearings, the difference between RDSO and measured and digitally recorded data was found to be 5 and 9 mm, respectively. In case of clear span, the manually measured data is not available, however, the digital data was recorded and shown in Table 3. The maximum difference between the RDSO and digital data was found to be 18 mm for the exterior span L0-L1 (Tto End). However, the difference between RDSO and digital data was found to be very small in the case of interior span. The schedule of dimensions at the cross-sectional view as per RDSO and predicted data from the digital model are shown in Table 4.

The schedule of the dimension diagram of cross-sectional view is shown in Fig. 6(b). The manual measurement on the cross-section views is always very difficult, therefore the cross-section views were not recorded manually. It was observed that the

digitally predicted track gauge spacing and distance between centres of the main girders was found to be the same as that of RDSO measurement. However, the difference between RDSO and digitally measured centre to centre distance between intersections and inner width was found to be 78 and -70 mm which is important to check these components and strengthen it accordingly. Further, it is to note that the small components such as sleeper height, contact wire height and Distance between knee bracings at contact wire height were not able to record digitally and the reason may be due to the lack of plan and missions involved in the PoC.

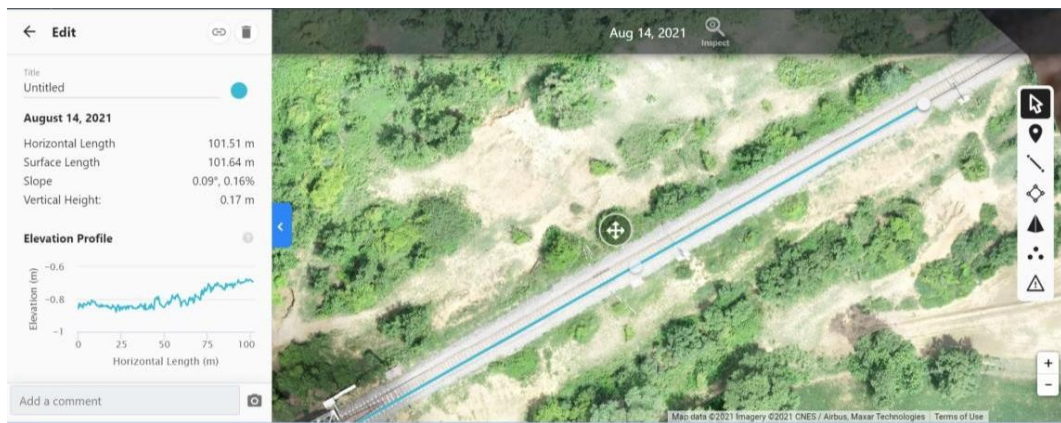
**Fig. 9 - Longitudinal section of 100m track on (a) tto end and (b) beas end.**

Further, the rail levels along the longitudinal section of 100m track on from Tto end to Beas end, were measured, see Fig. 9. The measured location is marked in a blue colour for both tto and beas end. Also, the rail levels are measured at every 5<sup>th</sup> sleeper and recorded digitally as shown in Table 10. It was observed that the sleeper levels at left and right-side rails were found to be almost the same and maximum deviation was found to be 6 mm, i.e., 300 mm and 306 mm at left and right side, respectively near tto end. However, the difference between the left and right-side rail was found to be almost negligible.

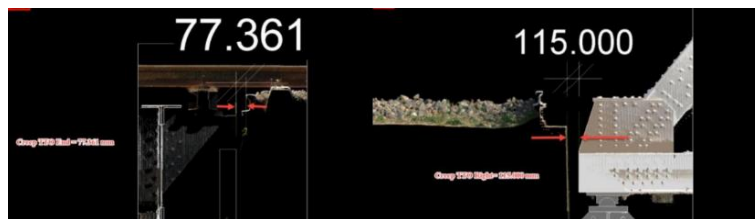
**Fig. 10 - Typical creep at the end of bridge.**

The creep is calculated through the measurement of distance between adjacent span or distance between end span and abutment. The creep measurement through the manual data and digital data are compared, see Table 11. The typical creep at the bracket and beas end is shown in Fig. 10. It was observed that the manually measured creep distance at the bracket found to be 35-42 mm whereas the same digitally measured data found to be 77-85 mm. The difference between the manually measured data and digitally measured data is almost 100% and the regular inspection may be required at such a location and to be retrofitted or strengthened with suitable techniques.

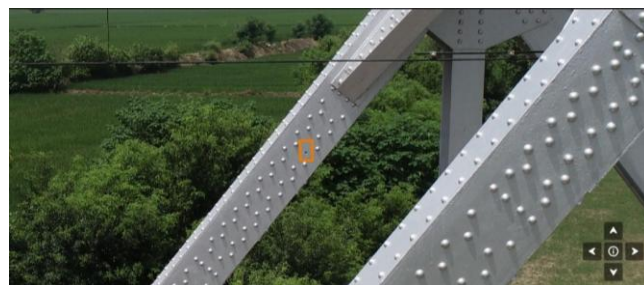
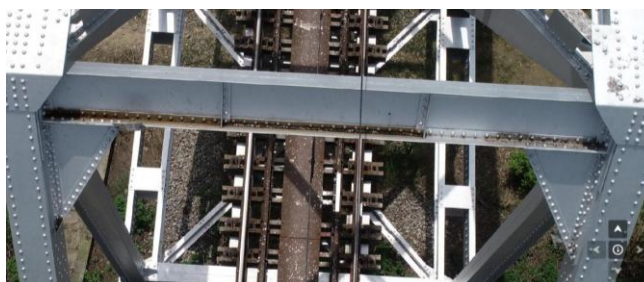
**(b)****Fig. 12 - (a) Missing rivet on diagonal member and (b) rusting on sway bracing.**

An important aspect of the methodology defining Critical Areas of Particular Interest (CAPI) for which high resolution photographs were to be taken, see Figs. 12(a-b). With the digital model, high resolution photos of any area can be viewed from multiple angles and analyzed for any deficiency or failure. These deficiencies such as rusting, missing or loose rivets (taking cue from rusting around them), hits marks, failure of masonry structures, flash marks from OHE, bearing abnormalities that can be possibly noticed. Accordingly, 2200 pictures were taken and are being sorted and analyzed. Visual inspections were performed through sample checks on different areas and locations of the bridges, see Table 13. It is concluded that the hi-resolution photographs with an option of machine learning in future developments and the machine examination may be compared with the drawings and previous inspection/pictures to be examined.
