# REVUE ALGERIENNE DES SCIENCES -A

## Hamam Meskoutine hydro-thermal cascade subsidence (North-East Algeria): Causes and effects on the landscape

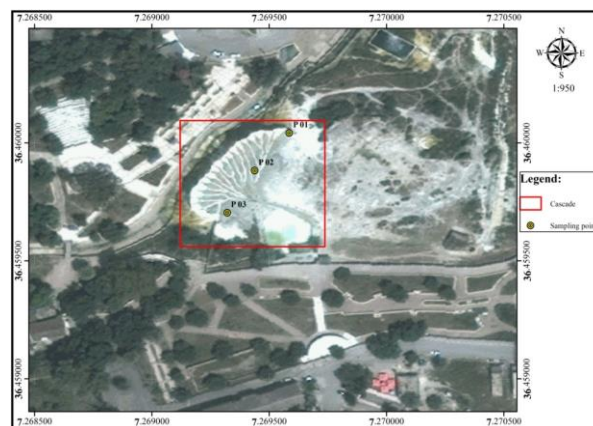
**Fig .3:** Localization of the sampling points

To study the physical characteristics of the rock, samples were taken in May 2014 from three observation sites (**Fig. 3**), from the rocks forming the cascade. To prevent the removal of weathered rock surface, a depth of 15 to 30 cm was reached to obtain the samples. The samples, cut off from their natural environment, were directly placed in a clean plastic bucket and delivered the same day to the LTP laboratory in eastern Annaba for analysis.

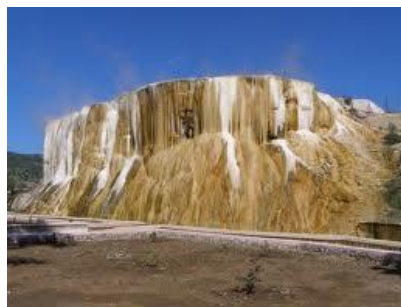
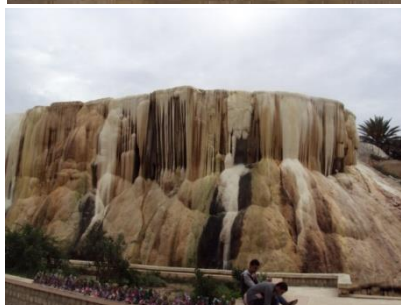
**Fig .8:** Development of the cascade.

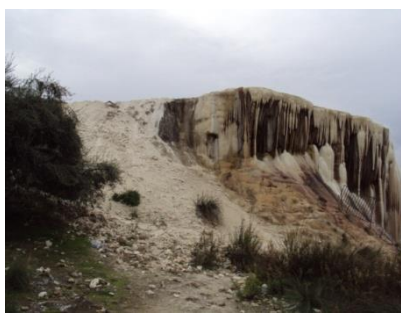
**Fig .9:** The collapsed

When diverting this water in a specific area, the water is deviated to another destination. The dehydrated part becomes fragile and vulnerable, then collapses. This has happened before when the water's course was changed, and as a result, pieces began to dry slowly and collapse, as confirmed by witnesses. This led to further study of samples taken by cutting through the rectilinear shear at different sampling points for laboratory testing.
