# Journal of Materials and Engineering Structures

## Dolphin Structures Health Monitoring: A Case Study in Hai Phong, Vietnam

Nguyen Anh Dan<sup>a</sup>, Nguyen Viet Thanh<sup>a,\*</sup>

<sup>a</sup> Faculty of Civil Engineering, University of Transport and Communications, Hanoi, Vietnam

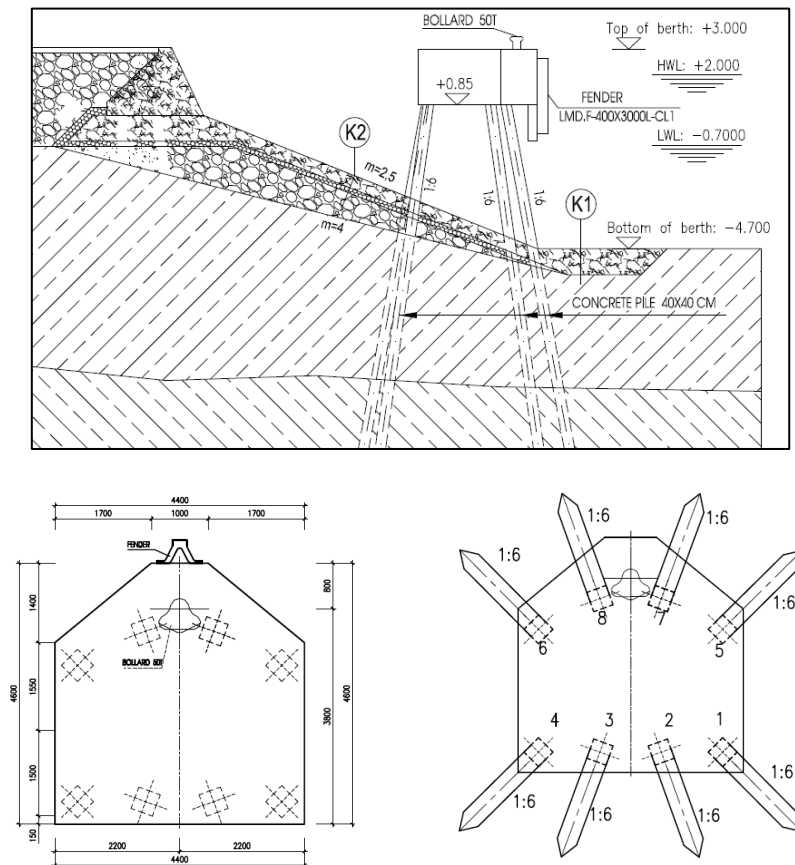
**Fig. 1 –Designed dolphin structure**

The investigated structure presented in this paper is located in Hai Phong, Vietnam. The structural characteristics are as follows: the dolphin is designed as a mooring and berthing structure for vessels of up to 2500 DWT. The foundation consists of a high-pile cap system with the cap supported by reinforced concrete square piles. The reinforced concrete (RC) cap has a hexagonal plan with overall dimensions of  $4.6 \times 4.4$  m and a height of 2.15 m.

The pile foundation consists of eight RC piles of  $40 \times 40$  cm. The outer row of piles is inclined toward the river with a slope of 1:6, while the inner row is inclined 1:6 toward the bank. The front face of the dolphin is fitted with a fender panel. Additionally, the structure is equipped with one 50-ton bollard and alamda fender type 3000L. Plan and cross-section drawings of the structure are shown in Fig. 1.

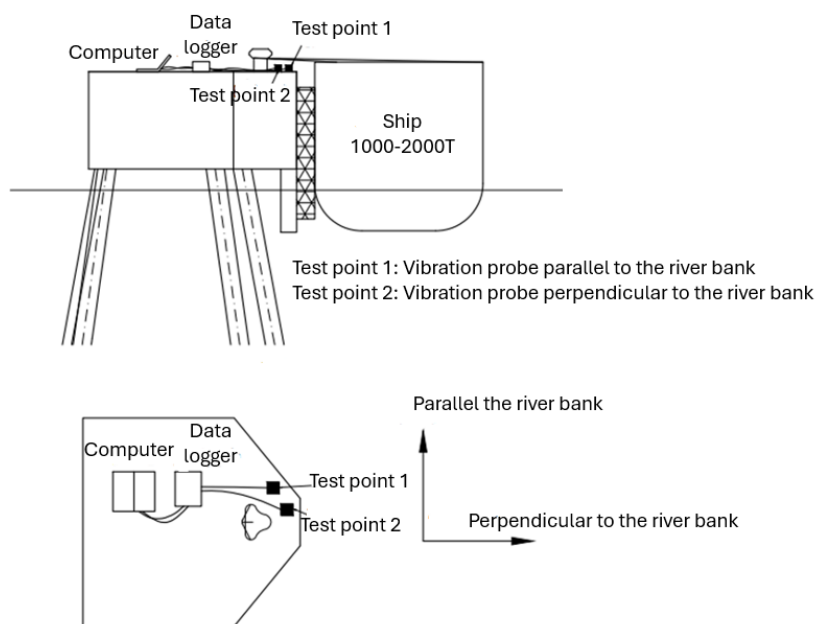
**Fig. 5–Layout diagram of vibration measurement**

To capture the dynamic behavior of the dolphin structure, two measurement points were strategically established: Point 1 was aligned parallel to the riverbank, while Point 2 was oriented in the perpendicular direction. The instrumentation suite comprised accelerometers and displacement sensors, which were securely fixed to the structural cap and interfaced with a centralized controller and computer system for real-time data acquisition.

Dynamic excitation was generated by the berthing operations of vessels with a displacement ranging from 1,000 to 2,000 tons. The resulting vibration signals were processed and analyzed using the Fast Fourier Transform (FFT) method to identify the spectral characteristics of the structure. The comprehensive layout of the vibration test is illustrated in Fig. 5, while representative photographs of the field measurement process are provided in Fig. 6.

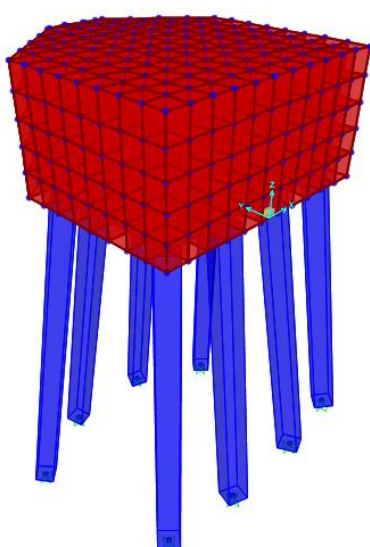
**Fig.11 - Numerical model for structural analysis**

The 3D model of the dolphin structure is presented in Fig. 11. The natural frequency results of the vibration mode in the direction parallel and perpendicular to the riverbank are illustrated in Figs. 12 and 13, respectively.
