# Journal of Materials and Engineering Structures

### Structural behavior of beam column joint retrofitted using carbon fiber reinforced polymer

Beam column joints are one of the most critical components of reinforced concrete (RC) structures since it is subjected to large forces during severe ground shaking. The present study comprises four exterior beam-column joint specimens having different reinforcement arrangements detailed as per IS 13920: 1993, tested under reversed cyclic loading up to failure. The test was force-controlled and the specimen was loaded by increasing the load level during each cycle. The load was applied forward cyclic and reverse cyclic and deflection, were measured from every 5kN by using a linear variable digital transducer (LVDT) with the digital arrangement. The deflection was measured at the loading point and at the centre of the beam. Damaged specimens were repaired and retrofitted with carbon fibre reinforced polymer (CFRP) to prevent shear damage and strength deterioration and to achieve a more ductile response. Retrofitted specimens were subjected to similar cyclic loading. Results for displacement were obtained. Hysteresis behaviour of non-retro

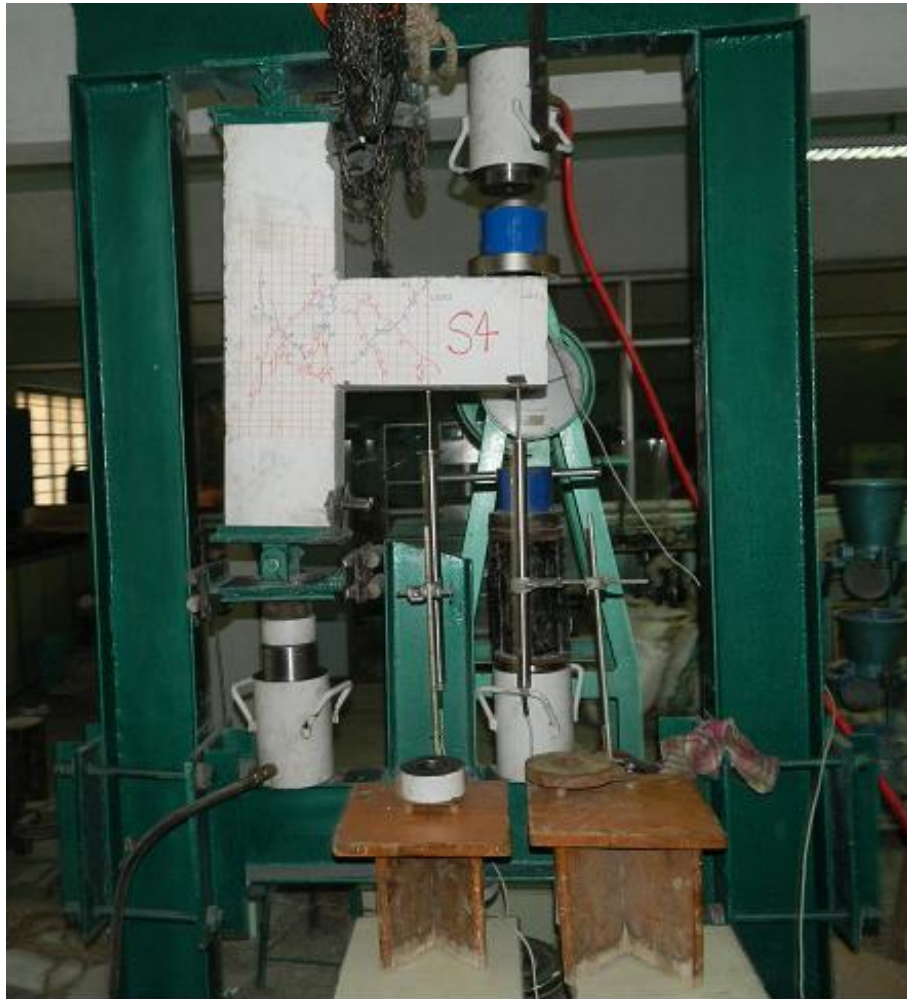
After curing all the test specimens were subjected to axial load and reverse cyclic loading. A constant axial load of 100 kN was applied with a hydraulic jack to the column, which is about 20% of the axial capacity of the column for holding the specimen in position and to simulate column axial load. Two ends of the column were given external axial hinge support.

**Fig. 3 – Testing Arrangement**

Another two hydraulic push and pull jack was used to apply reverse cyclic load to the beam portion. The point of application of the cyclic load was 50 mm from the free end of the beam. The test was force-controlled and the specimen was loaded by increasing the load level during each cycle. The load is applied forward cyclic and reverse cyclic and deflection measured from every 5 kN by using LVDT with the digital arrangement. The deflection was measured at the loading point and at the centre of the beam. Fig. 3 shows the test set up.

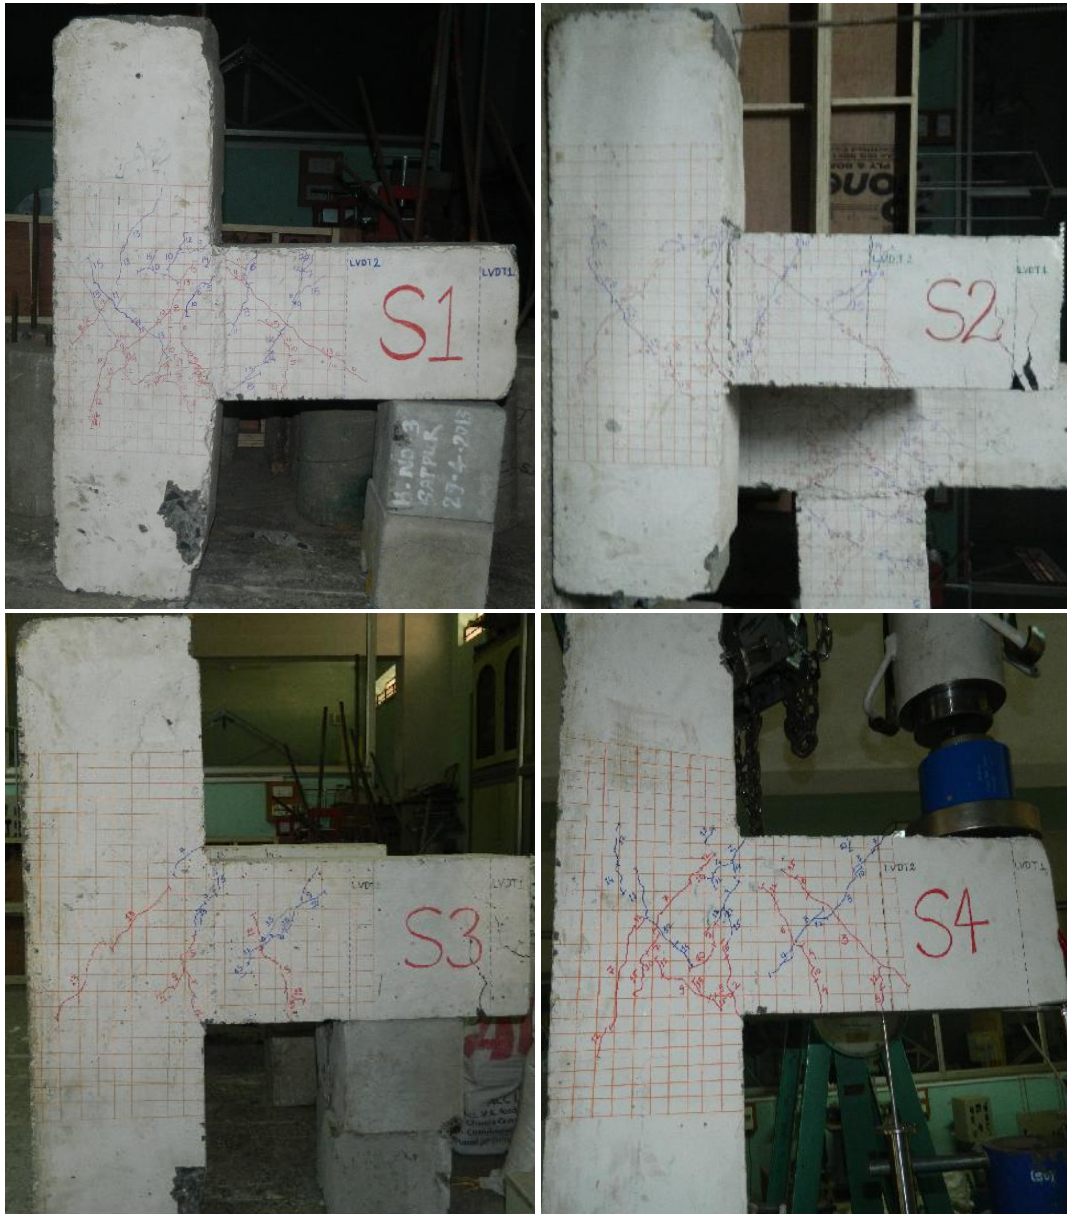
In the case of any damaged members, the first step is to rebuild the damaged member. Damaged specimens S1, S2, S3, and S4 as shown in Fig. 4 were first cleaned and made ready for retrofit. All cracks, voids, and irregular surfaces are finished with the help of putty. Putty is applied to smooth out the discontinuity, contaminants. When the putty was cured, a low viscosity primer coat of JSRprime is applied with the help of roller and brush, within the pot life period of 45 minutes of the mixture. JSRprime is a two-component adhesive system comprises a colorless base epoxy resin and amber-colored hardener as shown in Fig. 5(a), both are mixed in a ratio of 100(Base):50(Hardener) by weight as per the manufactures instruction manual. Primer is applied to promote adhesive bonds for saturating resin. The inappropriate ratio would result in inferior end properties. The mixture is stirred to ensure full homogeneity. It is then allowed to cure as shown in Fig. 6(a).

**Fig. 4 – Damaged Specimens after testing (S1, S2, S3, S4)**

**Non-retrofitted specimen:** The general cracking pattern for the non-retrofitted specimens S1, S2, S3 and S4 under reverse cyclic loading is as shown in Fig. 4, from which it is observed that, flexural cracks appeared at the beam bottom face close to the beam column joint interface during the positive loading cycles. The same happened at the top surface of beam

during the negative loading cycle. The cracks were almost symmetrical on both the faces of the beam column joint. At the lower stages of loading for the entire four specimens, minor shear cracks initiated diagonally at the joint interface and propagated in the joint region. Also, some inclined shear cracks were observed in the beam portion. However, cracks in the column were much less than those in the beam. This may be due to the column is subjected to a high axial compressive load; the net tensile stresses which may lead cracking in the column are quite small. Further, some vertical cracks were also observed in the beam, which may be occurred due to high flexural moments in the beam at higher stages of loading. All specimens behaved in the same manner with widening of diagonal shear cracks at the joint interface and cracks in the beam portion, ended at joint interface. In case of S1 and S4 specimen, more number of finer cracks was developed in joint region, at the joint interface and in the beam portion. The joints were finally failed due to expansion of these cracks. However, in S1 specimen, crushing of concrete at the top of column was observed where the column was hinged. Now, in S2 specimen major crack widening was observed at the loading point which resulted in the failure of the S2 specimen. Similarly, S3 specimen also failed due to crack occurred at the loading point. This type of failure was different than failure of S1 and S4 specimen.

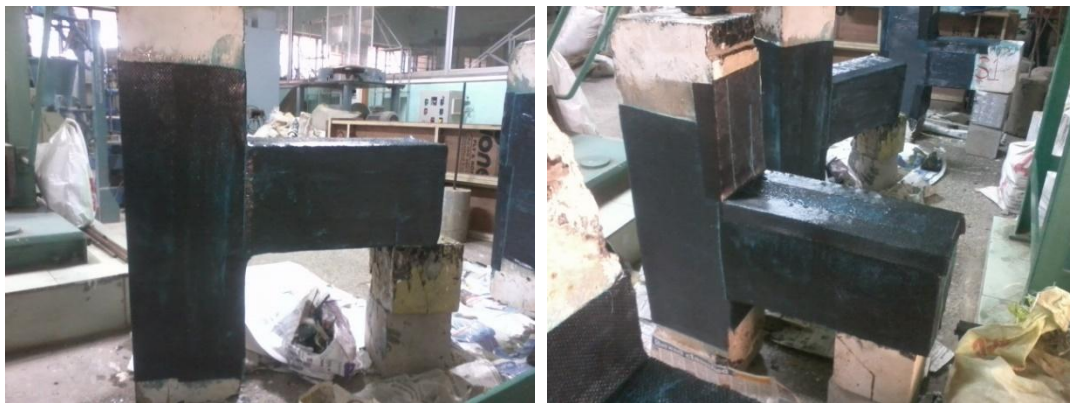
For wrapping, a wet layup process was adopted to ensure better wetting of fibres in the resin. These pre-wetted sheets were then carefully placed on the primed surface of beam-column joint specimen by giving a little hand pressure. Care must be taken to remove all air pockets therefore rolling is done in the direction of fibre. Wrapping must be completed within the pot life period of the resin that is 15 minutes. Therefore, a small quantity of resin was mixed at a time. Retrofitted specimens as shown in Fig. 7, were cured in the air for a period of 7 days and then tested as per the same procedure adopted before. Damaged specimens S1, S2, S3 and S4 were retrofitted and named as RS1, RS2, RS3 and RS4 respectively.

**Fig. 7 – Retrofitted beam column joint specimen**

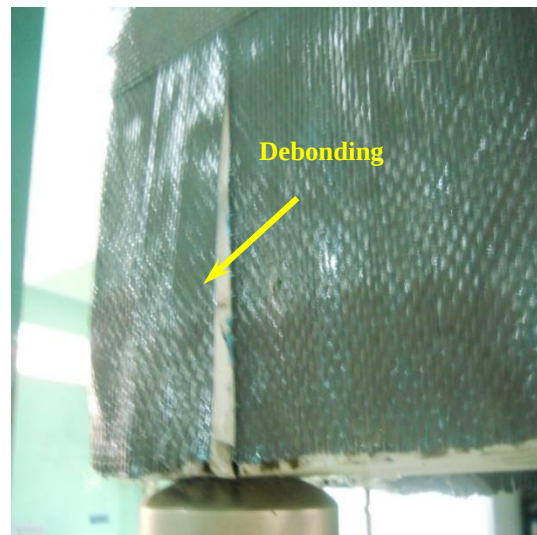
**Fig. 9 – Debonding of CFRP in RS3 Specimen**

However, RS3 specimen failed very poorly due to CFRP debonding at the point of loading in initial period of loading as shown in Fig. 9. This may be attributed to poor bonding of CFRP in that region. But it is not the same case in RS2 specimen. Though the S2 specimen was failed at the loading point but after retrofitting as it was perfectly bonded to concrete, it has taken the load similar to that of parent specimen. Therefore, it may be concluded that proper bonding should be achieved for better confinement to the concrete and to enhance the shear strength of joint. No damage was observed in the column and joint region. Thus it proves that strong column weak beam philosophy. Thus, CFRP wrapping to the beam column joint shifted the joint interface failure in the beam portion.
